LLNL Lessons Learned LLNL

LL-2005-LLNL-02

Reevaluate Hazards When the Scope of Work Changes

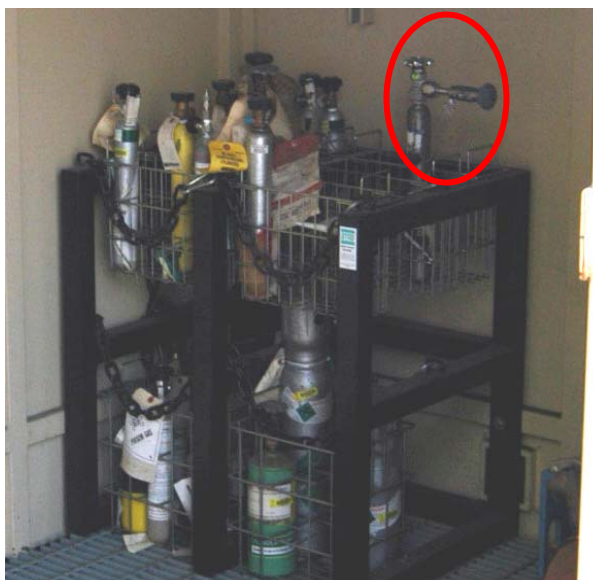
A third worker in the chemical storage unit decided to remove a sidearm flow valve (see Figure 1) from an unrelated small lecture bottle located nearby, which contained 99% deuterium fluoride (DF) gas. The cylinder had been in storage for approximately two years, but appeared to be in excellent condition. The worker determined that the removal of the sidearm valve did not require a work permit, as the work was self-authorized.

Figure 1. Gas bottle storage area prior to the event.

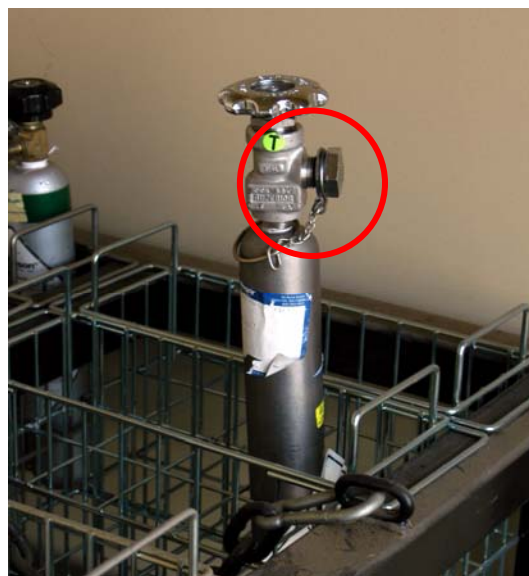
Figure 2. Bottle with cap installed after the event.

- Although the lecture bottle appeared to be in excellent condition and the valve appeared to be closed, this could not be verified without testing or handling. There was no way to evaluate if residual gas was left in the tubing between the sidearm valve and the cylinder shutoff valve. These factors should have prompted a thorough review of the hazards and development of controls.

- The DF cylinder was not in an approved storage configuration. The LLNL *ES&H Manual* states that valve plugs shall be installed as a final barrier against leakage when cylinders are moved, and that valve protective devices or caps and gas tight valve outlet caps or plugs shall be kept in place when cylinders are stored.

5. Exercise caution when working with gas cylinders and regulators. The condition of a gas cylinder, regulator, or valve cannot be assessed based only on appearance.

7. Wear the appropriate PPE when changing or removing sidearm valves, regulators, manifolds, or other components from a gas cylinder, even though the potential exposure may appear to be very low.
